Re: 402 and 410 102nd Avenue SE
Bellevue Critical Areas Land Use Application No 15-103115-LO

MEYDENBAUER STREAM HABITAT ASSESSMENT

TAMASHA APARTMENTS - BELLEVUE

JANUARY 2016

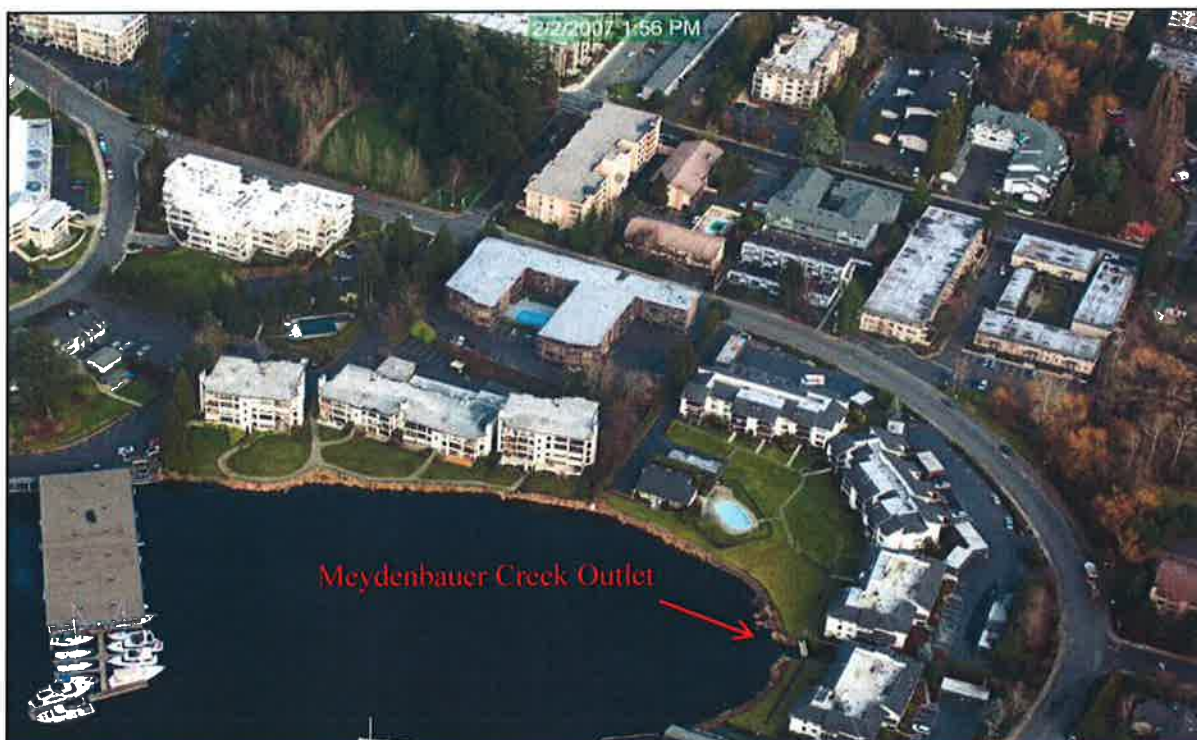
Figure 2. Location of Meydenbauer Creek Outlet, Lake Washington.

The drainage feature flows west offsite through metal grate and box culvert and then south along 102nd Avenue in a 90 foot long, 15 inch diameter culvert which has been identified as a fish barrier by the City (City of Bellevue, 2015). Then it is channeled into a 176 foot long, 60 inch diameter, corrugated metal pipe. This pipe discharges into an approximate open channel on parcel number 0666000405 before it re-enters stormwater infrastructure and flows west toward Lake Washington, until finally draining into Lake Washington (Figure 2).

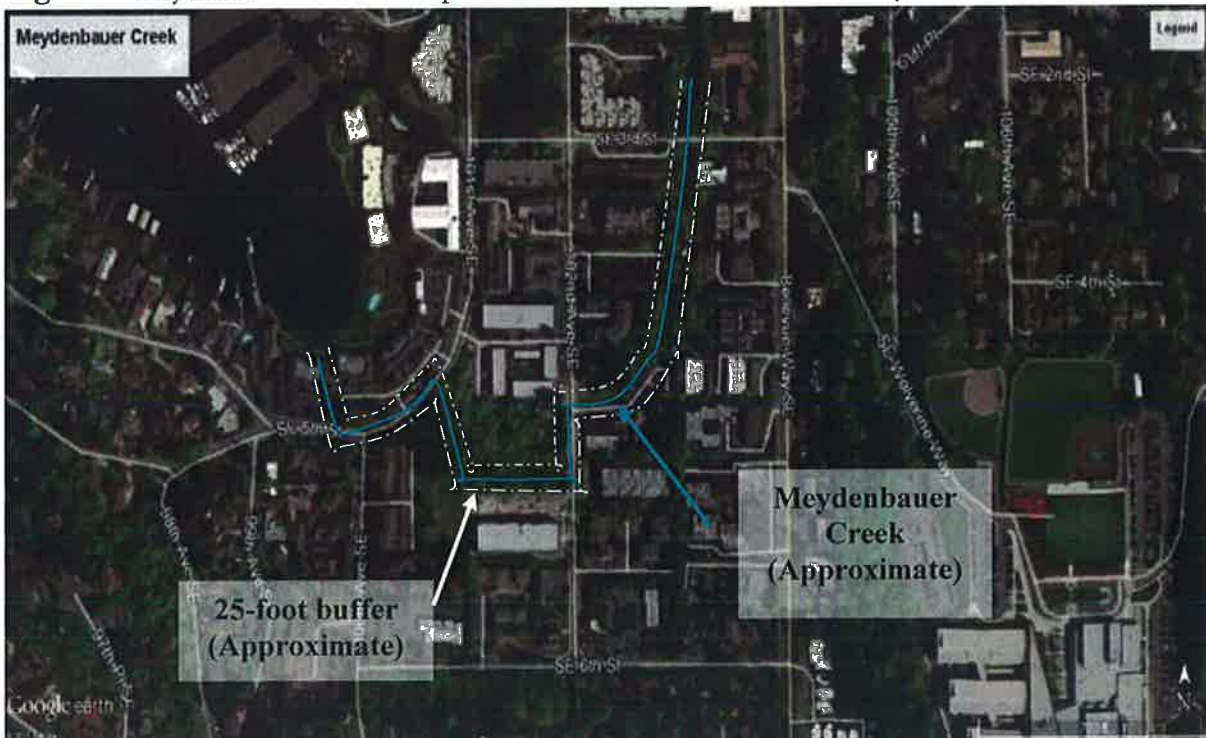
Figure 3. Meydenbauer Creek with potential 25-foot stream buffer overlay

As the onsite drainage feature appears to be a non-natural, man-made stormwater conveyance system, an analysis of BMC indicates a buffer or setback should not be applied. However, if the City of Bellevue choses to call this portion of Meydenbauer Creek a natural stream, the feature should be considered a Type O water as determined in Section 342 of this report. Type O waters, require a 25 foot buffer under BMC 20.25H.075.C.1. This buffer is consistent with previous development which has occurred along Meydenbauer Creek as can be observed from Google Earth aerial photography (Figure 3). In addition, the City of Bellevue previously determined that a downstream reach of Meydenbauer Creek on an adjacent plat was also subject to a 25 foot buffer, indicating that a 25 foot buffer and 10 foot setback on the subject property would be consistent with surrounding properties (City of Bellevue, 2013).

The site is considered undeveloped due to the lack of primary structures. The onsite drainage feature does not have a closed stream segment and is not located in the West Tributary of Kelsey Basin. The out-of-use existing structure onsite does not encroach on an existing critical area buffer or structural setback. No existing permitted buffers or setbacks are associated with the onsite drainage feature, and thus there is no need to modify measurements of critical area buffer to account for stream bank erosion, or previous restoration plans or reach studies. Pursuant to BMC 20.25H.075.C.1, if the feature is considered natural by the City of Bellevue, the drainage feature is an open water channel along most of the site and is located on an undeveloped site and a standard 25-foot buffer and 10 foot

structural setback (BMC 20.25H.075D) would pertain to this feature. The first 50 feet onsite, east of the sidewalk along 102nd Avenue Southeast is culverted and in this location the Creek is not open, thus it does not require a buffer in this portion of the site.

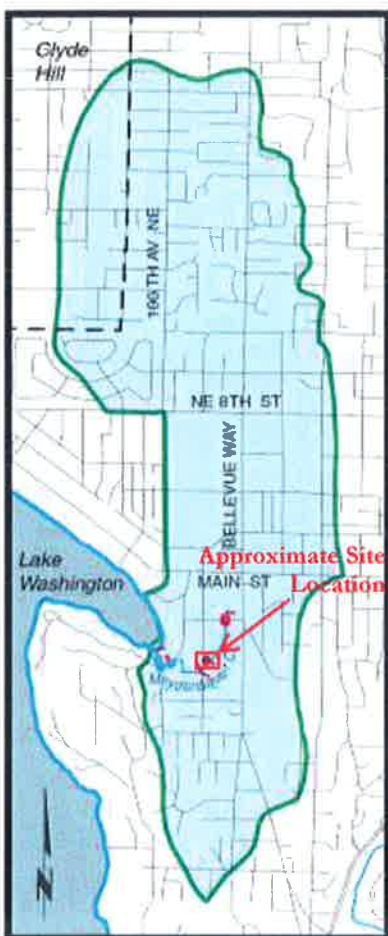
Appendix A1. Meydenbauer Creek Basin

Basin Areas: 927 Total Acres
 City 832 Acres
 Clyde Hill 95 Acres

% Impervious 53%
 Basin Relief 184ft
 Basin Energy 0.3
 Basin Length 2.2 mi
 Average Basin Width 0.7mi

Fish Use: Lower Meydenbauer Creek (08-0258) is a fish-bearing stream. The historical record mentions local residents fishing for trout and salmon (McDonald 1984). The stream likely supported both resident and migratory cutthroat trout; the salmon mentioned in local histories were likely coho. Adult sockeye salmon, cutthroat trout, scalpin and stickleback have been noted in Meydenbauer Creek downstream of 101st AVE SE in both 2000 and 2001.
